# LEVEL 1 REPLACEMENT RESERVE REPORT FY 2025 WINDSHIRE PARK METROPOLITAN DISTRICT NO. 2

## WINDSHIRE PARK METROPOLITAN DISTRICT NO. 2

WINDSOR, COLORADO  
June 30, 2025

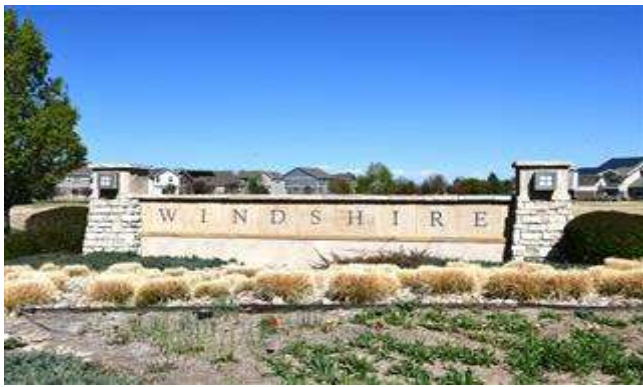
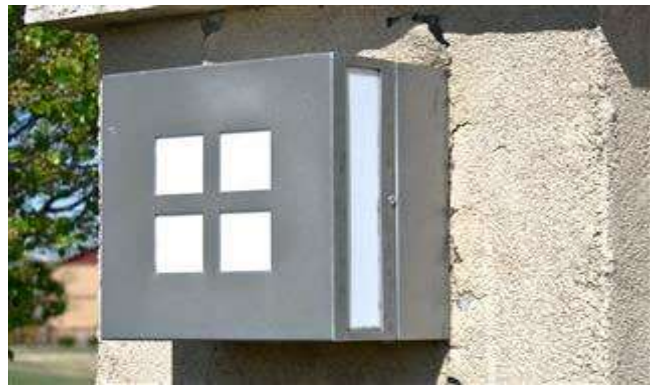
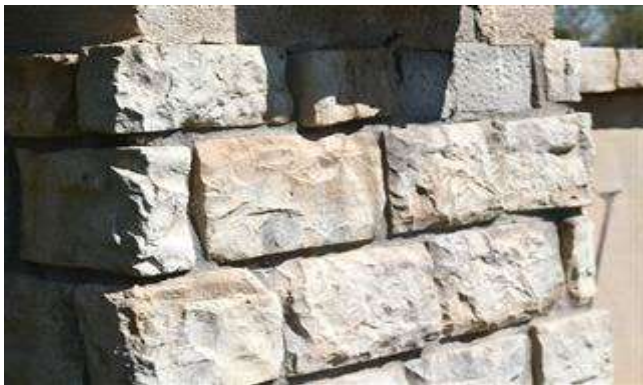
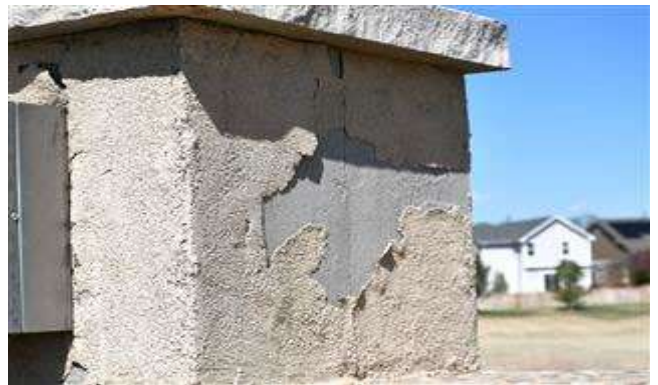
The decorative monument lights have plexi lenses, and some of these lens covers have fallen out. These lights appear to be in overall good condition and can have a useful life of approximately 30 years. Since these lights will most likely all fail together, the study has 1/3 of the lights replaced every 10 years.

We recommend re-pointing and replacement of defective areas of the masonry as needed. The Metro District may want to consider applying a coating of Siloxane or other appropriate breathable sealants to mitigate water penetration and further degradation of the masonry work. The stucco surfaces should be cleaned and new stucco applied.

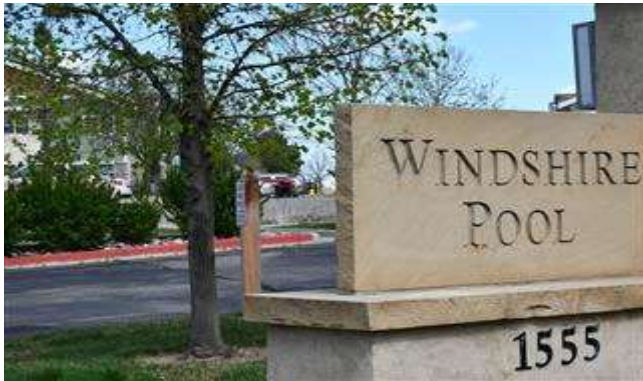
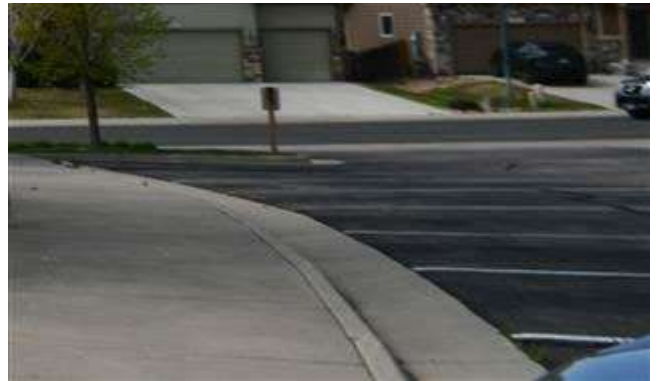
**Asphalt Pavement.** The Metro District is responsible for the pool house parking area. The City, County, or other municipality maintains other roadways. In general, the District's asphalt pavement appears to be in good condition.

The defects noted include the following:

- **Seal Coating.** The asphalt should be seal coated every five to seven years. For this maintenance activity to be effective in extending the life of the asphalt, cleaning and crack repair should be performed first.

The pricing is based on recent contracts for a two-inch overlay, which reflects the current local market for this work.

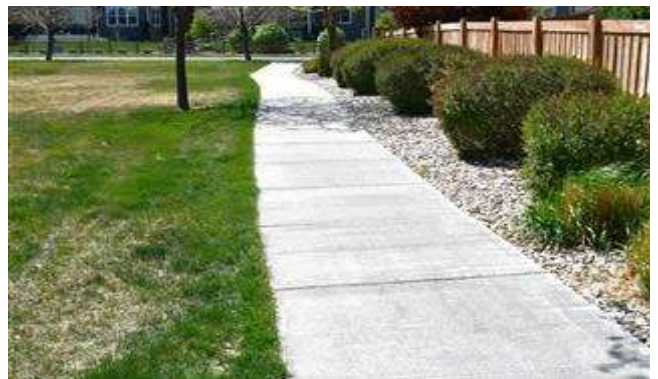
**Concrete Work.** The concrete work includes the Metro District sidewalks and pool area curb and gutters. We have modeled for curb replacement when the asphalt pavement is overlaid. The overall condition of the concrete work appears to be good.

- Trip hazard, ¼ inch height difference.
- Severe cracking.
- Severe spalling and scale.

Because it is highly unlikely that all of the concrete components will fail and require replacement in the period of the study, we have programmed funds for the replacement of these inventories and spread the funds over an extended timeframe to reflect the incremental nature of this work.

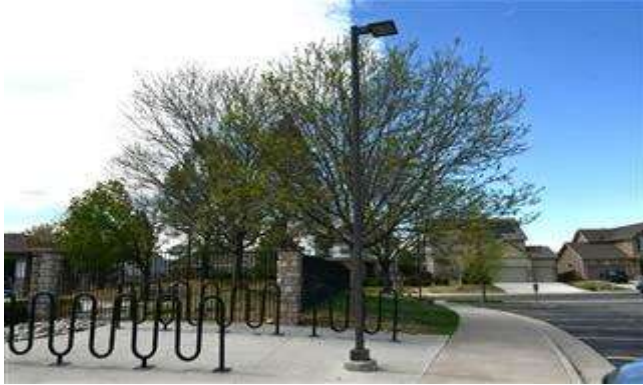
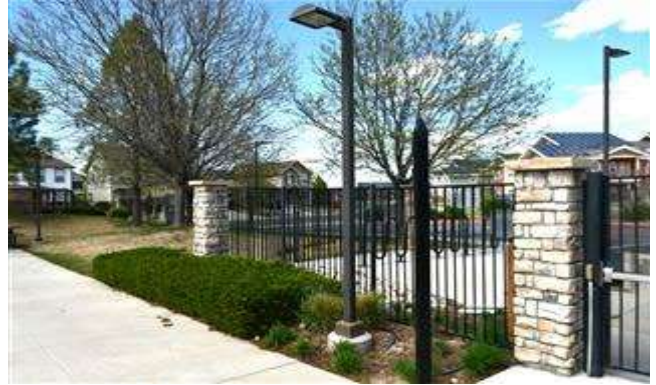
**Site Lighting.** The Metro District is responsible for the operation of the pool area pole lights that appear to be in good condition. The lights were not on at the time of our site visit, but we understand they remain in good operating condition.

This study assumes the replacement of the light fixtures every 15 to 20 years and pole replacement every 40 years. We assume that the underground wiring will also be replaced along with the light pole.

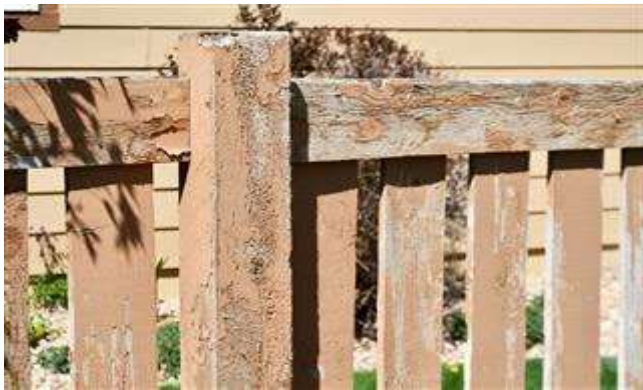
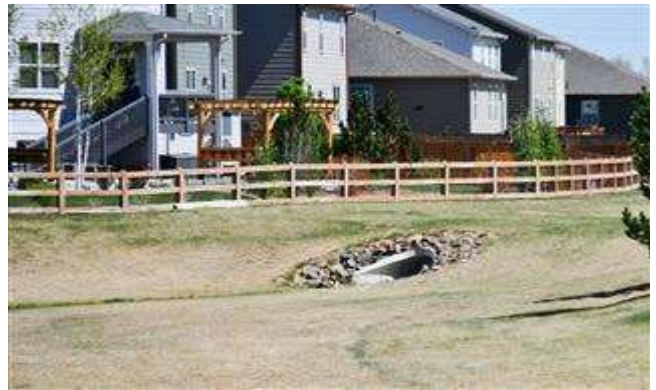
**Wood Board Picket Fencing and Split Rail Fencing.** The Metro District maintains wood fencing that separates the yards from the District's open space. The fencing systems were installed in phases within the community as the District continued to grow, and subsequently, the fencing is in various conditions. The community has been separated into 6 areas, where each area has a defined construction window. The fencing cleaning, staining, or replacement will be scheduled based on the 6-phased areas based on the original construction dates. Protection from weed trimmer string during lawn maintenance can extend the useful life of some fence types. Protection from this type of damage is typically provided by applying herbicides around post bases or installing protective sheathing.

The study model for both the picket and split rail fencing has the fencing with a useful life of approximately 28 years. To allow the fencing to last 25 to 30 years and maintain a quality finish, the study plans for power washing and staining of the fencing every 6 years. Phase 1 of the community was constructed in the 2004 timeframe, and the fencing within phase 1 is reaching the end of its useful life and was previously painted. The paint never adhered properly to the Phase 1 fencing, so it appears in poor condition. Phase 1 fencing is scheduled for replacement in 5 years. The remaining phases will be stained with a quality fence/deck stain that should perform better than the painting that was done on the phase 1 fencing.

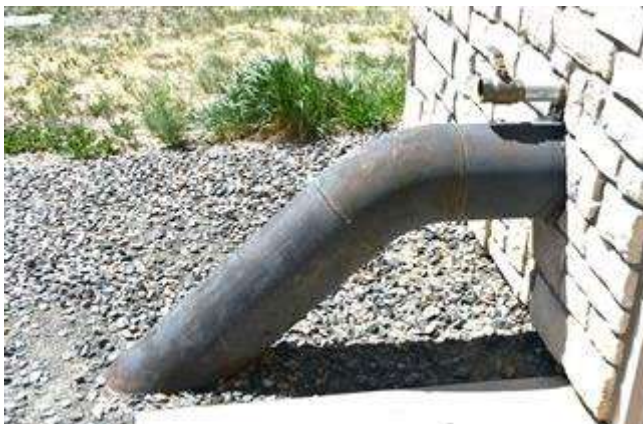
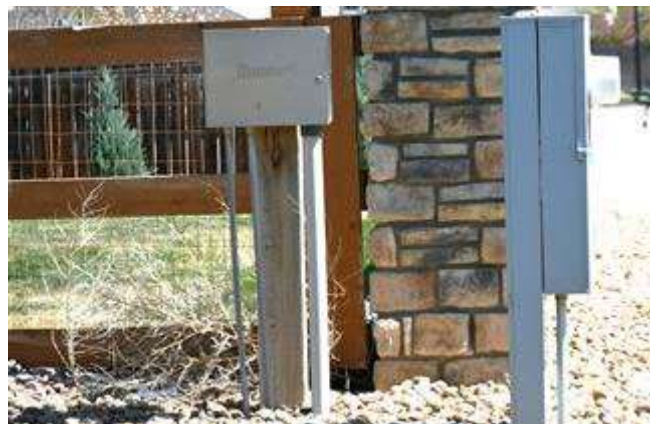
**Pump House Building.** There is a pump house to support the irrigation pond to provide pressurized irrigation water to the Metro District. The exterior of the pump house has a stone veneer finish with an asphalt shingle roof and a double service door. The exterior surfaces appear to be in good condition. Asphalt shingle roofs can have a useful life of 20 to 30 years, depending on the weight and quality of the shingles. Weathered, curled, and missing shingles indicate they may be nearing the end of their useful life. The study model has a 30-year NEL for the asphalt shingle roofing. The stone veneer siding should last the life of the building but will need occasional tuckpointing of the grout joints (similar to the entry monuments). The study has 10% of the stone veneer tuckpointed every 10 years.

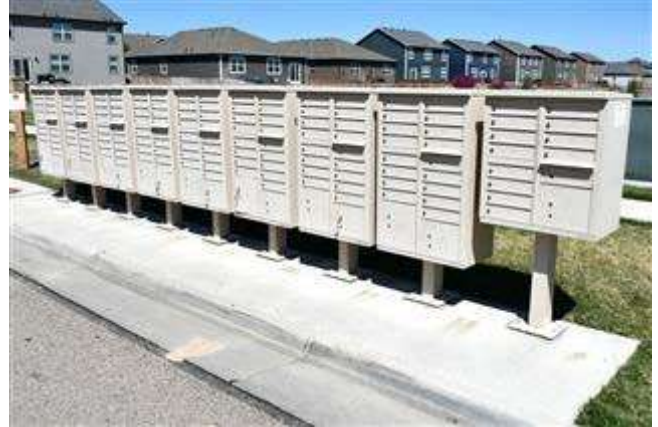
**Mailboxes.** The Metro District maintains pedestal mailboxes located throughout the community. The mailboxes include a pedestal and boxes. They are generally in good condition.

There are a total of 42 mailbox pedestals, from 8 mailbox clusters to 16 mailbox clusters. The model assumes that 6 mailbox pedestals will be replaced every 5 years (7 phases) for a total useful life of 35 years each.

Mailboxes should be maintained to the extent that rust does not develop on the structure or pedestal, and all mail slot doors remain intact with operable hinges and locks. Our replacement estimate assumes that these units will be replaced with similar units in the future.

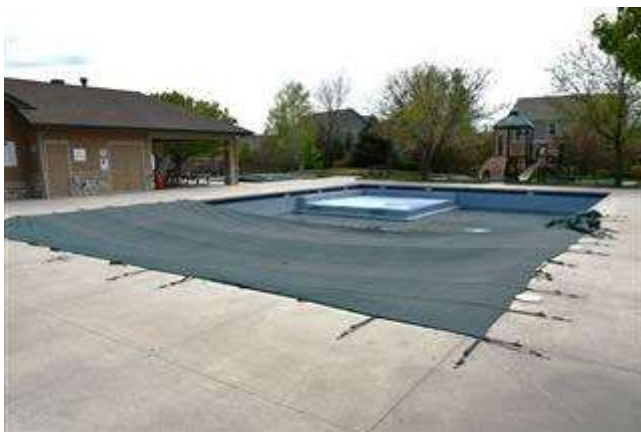
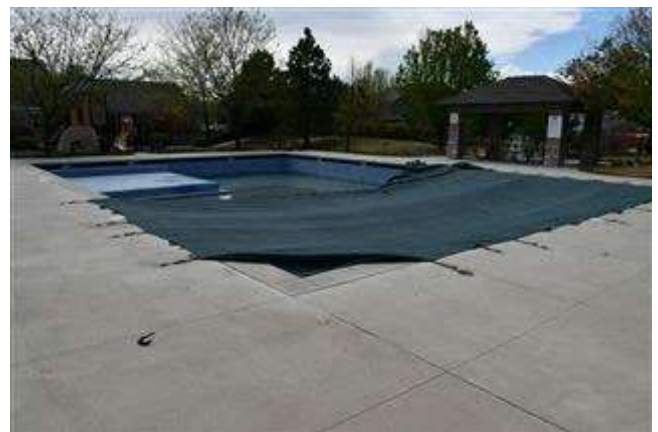
- **Pool Fence.** The swimming pool is enclosed by a metal fence that appears to be in good condition. The metal fence will be replaced under the Fencing section of the report.

- **Pool Furniture.** There are numerous pieces of pool furniture that appears to be in good condition. It appears the pool furniture has been replaced in phases, and the study assumes similar replacement phases in the future.

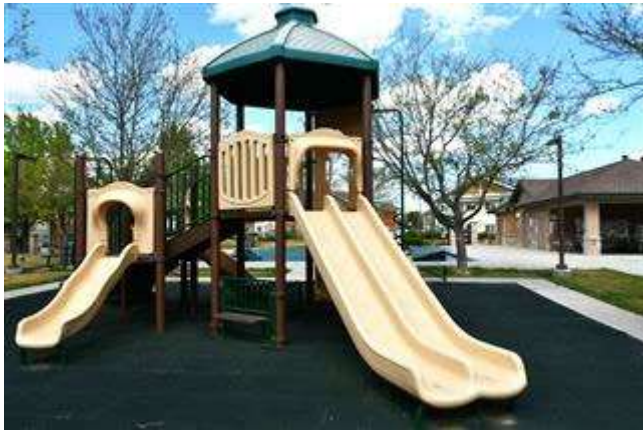
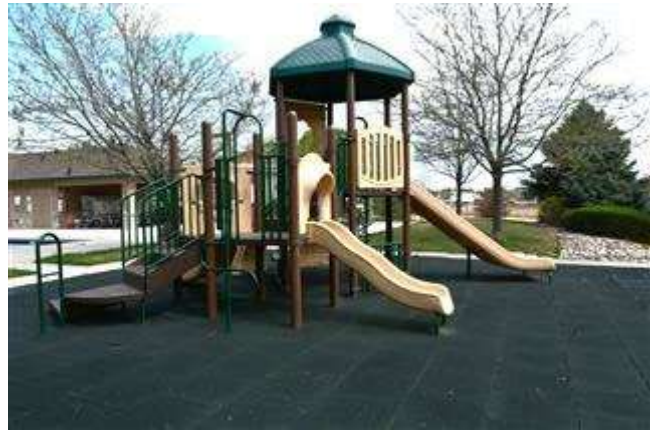
**Tot Lots.** The community maintains a single tot lot. The tot lot includes a play structure, a concrete border, and a synthetic safety surface. The play structure appears to be older, but in surprisingly good condition for its age. The synthetic safety surface is starting to show wear, and some of the squares are starting to roll up on the edges.

Our estimates for playground equipment are based on comparing photos of the existing equipment with equipment of a similar size in manufacturers' catalogs. We used the pricing quoted by manufacturers for comparable equipment and added 30% for the disposal of the old equipment and installation of new equipment.

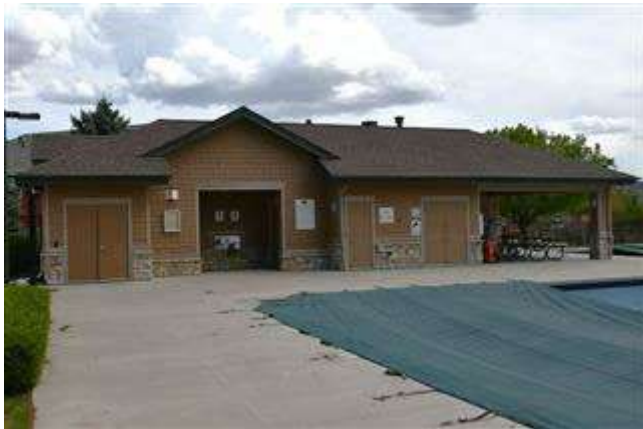
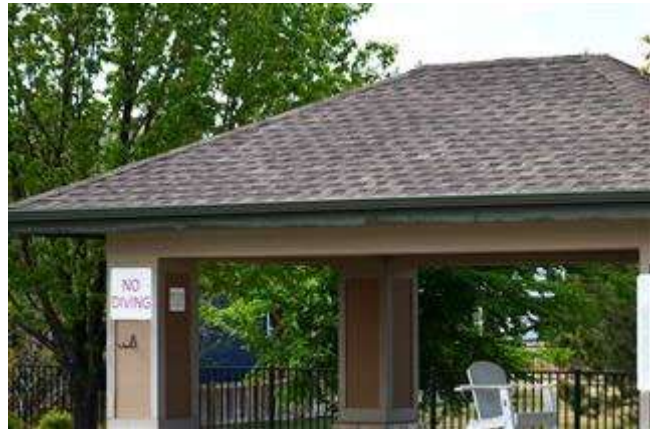
**Roofing.** The pump house building, along with a single pavilion, has asphalt single roofs that appear to be in good condition.

Access to the roof was not provided at the time of the site visit. Annual inspections are recommended, with cleaning, repair, and vegetation mitigation performed as needed. Contractors and personnel should perform access, inspection, and repair work with the appropriate access equipment experienced in the roofing types used for the facility.

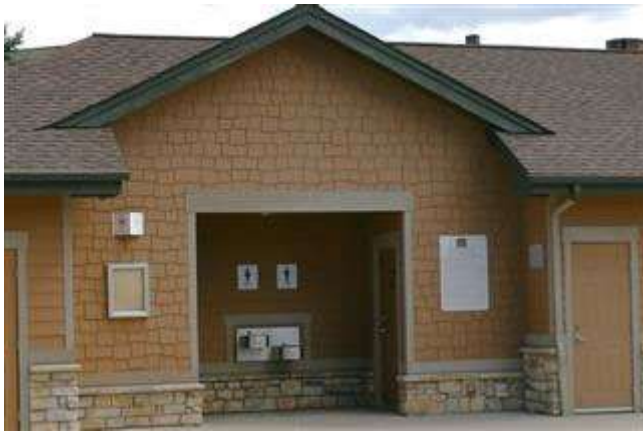
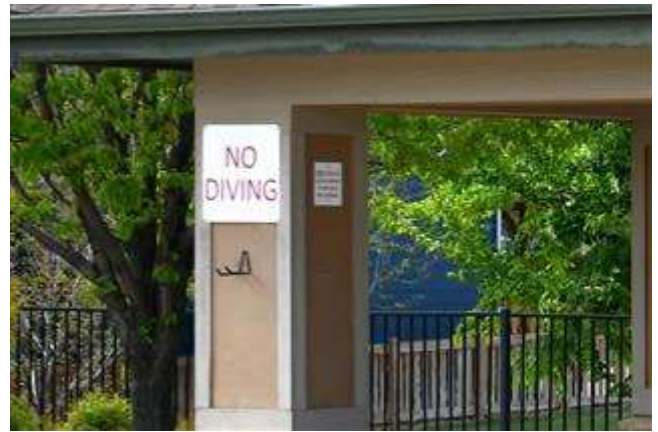
**Gutters and Downspouts.** The pump house has gutters and downspouts. The gutters and downspouts appear to be in good condition. The replacement timeframe is scheduled to match the replacement of the siding and trim.

The wooden exterior materials have a normal expected life of approximately 40 years, with painting cycles for wooden exteriors varying between five and ten years, depending on the wood grade, the materials' quality, and the finish work. In this study, we have modeled for wood painting cycles every 5 years. When the wood siding and trim are finally in need of replacement, the District should consider replacement using low-maintenance synthetic or cementitious materials as an alternative to high-maintenance materials. Cementitious materials typically have an extended useful life and require repainting and recaulking every 10 to 15 years. Following the manufacturer's recommendations for cleaning, painting, and caulking, we expect cementitious products to have a useful life in excess of 50 years or more.
